Docket No. 217 – Development and Management Plan Inspection

Northeast Utilities Service Company Certificate of Environmental Compatibility and Public Need for the construction of a 345-kV electric transmission line and reconstruction of an existing 115-kV electric transmission line between Connecticut Light and Power Company's Plumtree Substation in Bethel, through the towns of Redding, Weston, and Wilton, and to the Norwalk Substation in Norwalk, Connecticut.

Date: October 27, 2005

Location: 345kV Underground Route

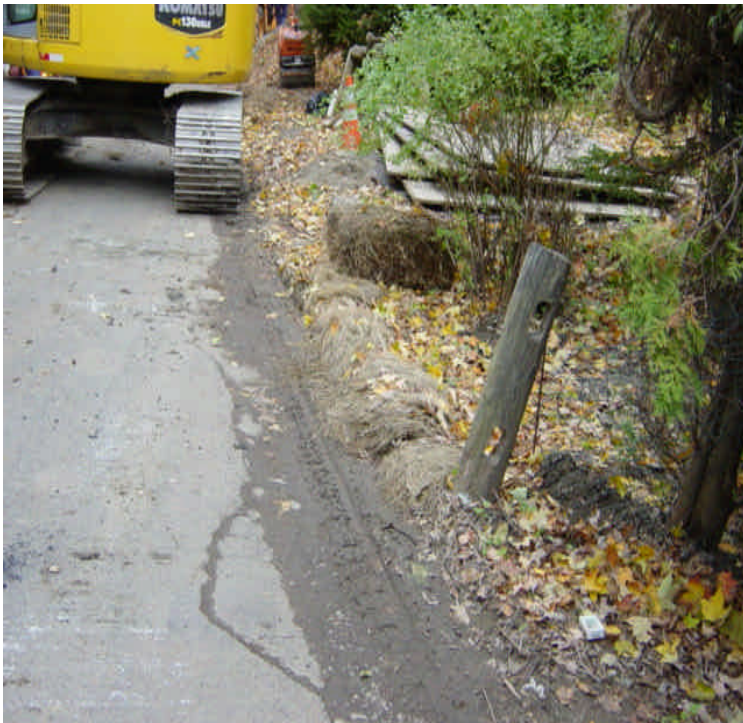
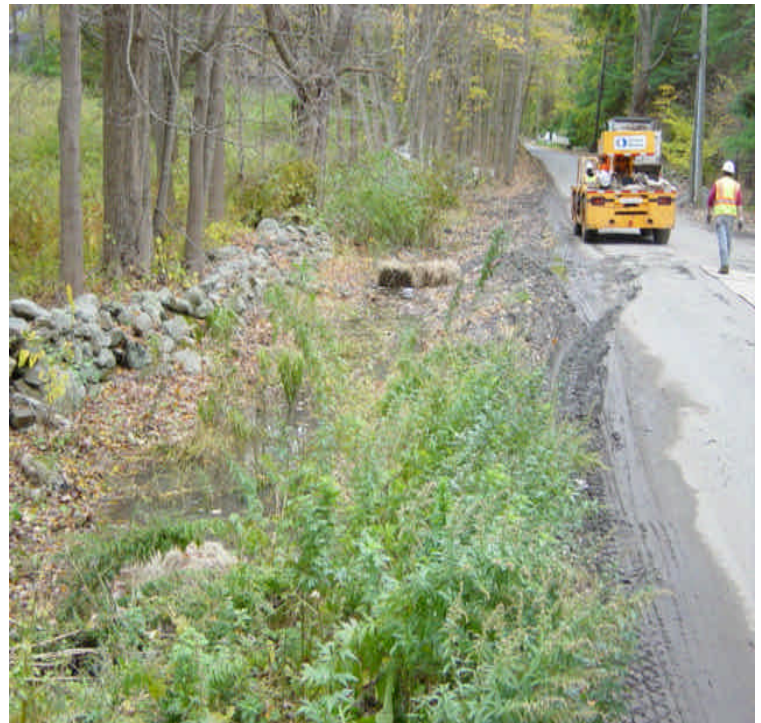
345kV (Umpawaug Rd Daywork): The photo on the left shows some sediment along the edge of the road which should be contained. The photo on the right shows haybale check dams placed in the wet swale. Continue to regrade any ruts here. 10/27/05

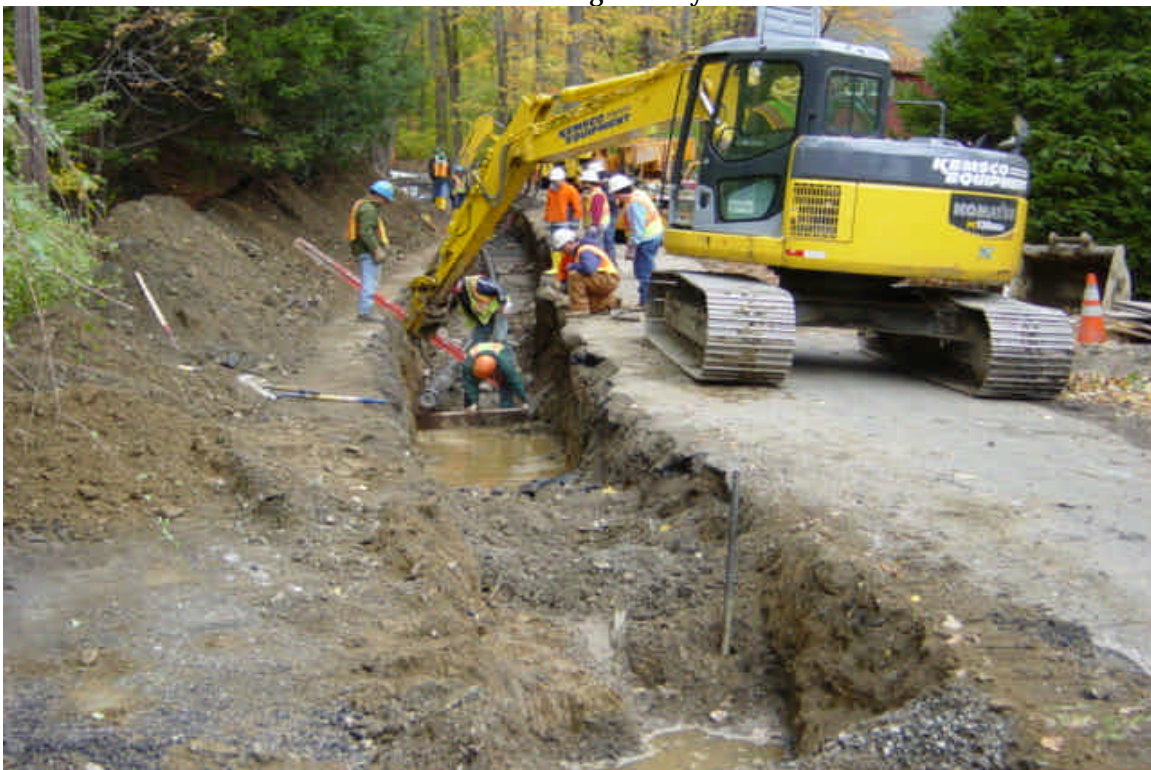
View of the trenching operation along Umpawaug Rd. Be sure to place all stockpiles back within the trench at the end of the day. Otherwise, silt fence is needed at their base. 10/27/05

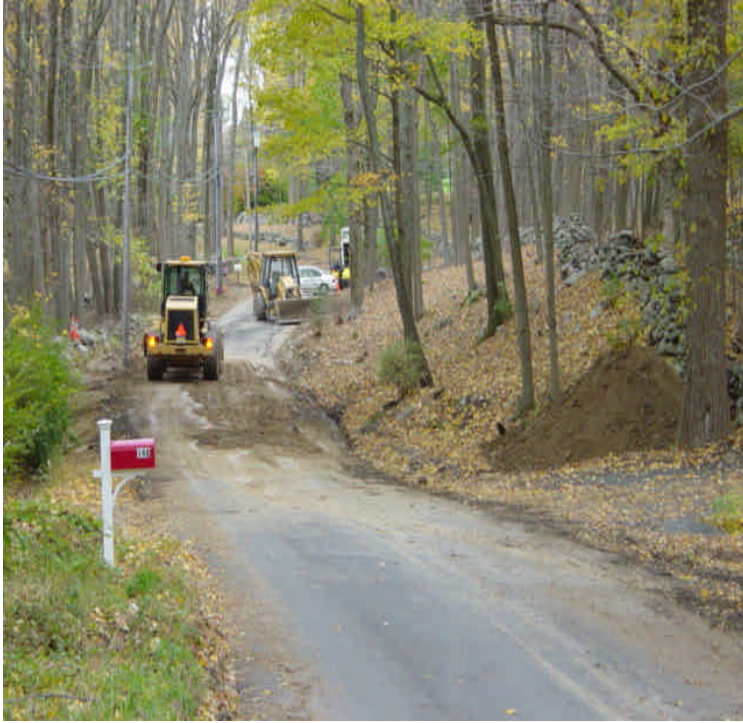
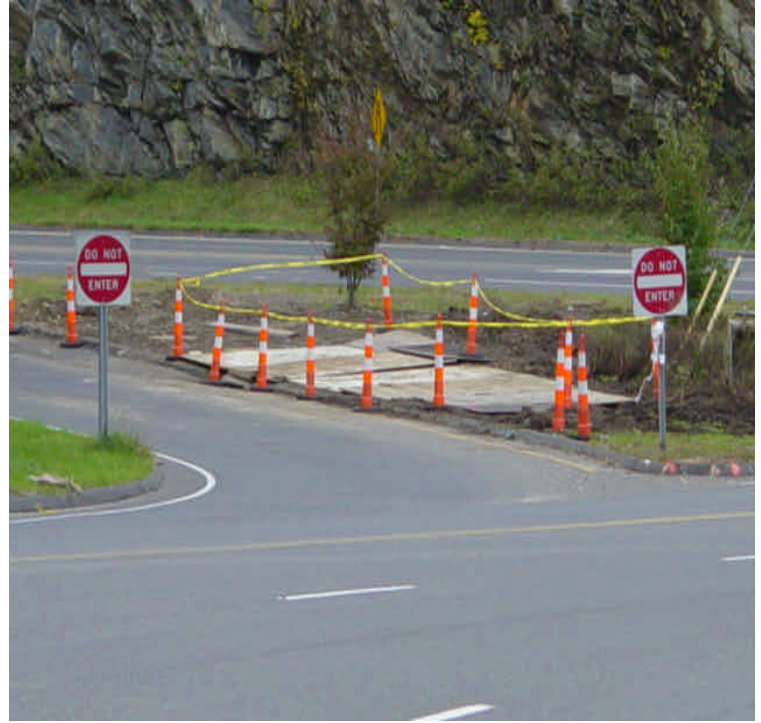
345kV The photo on the left shows work continuing along Umpawaug near the Diamond Hill Rd. intersection. Erosion controls should be installed, especially downgradient of the stockpile. Photo on the right shows work around the vault in the island between Rt. 7 and 107. 10/27/05

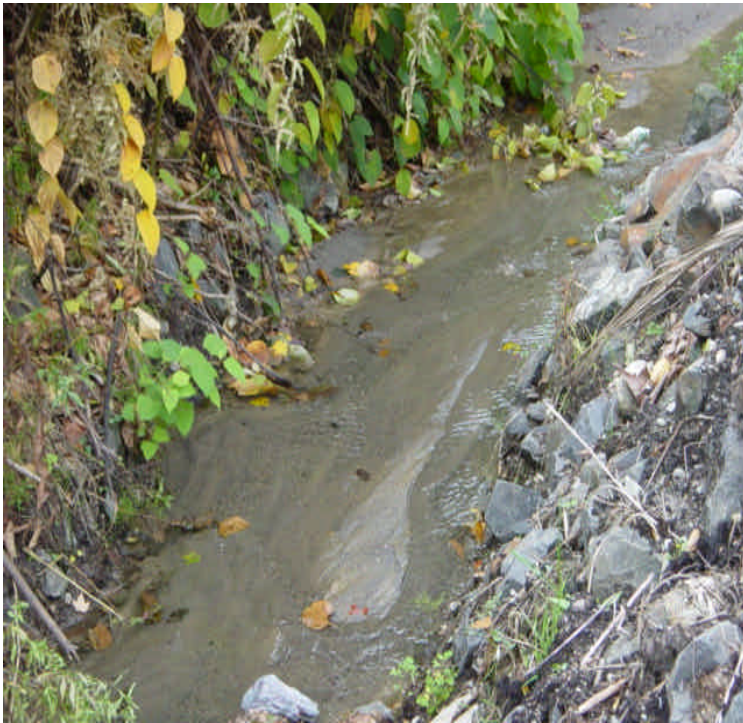
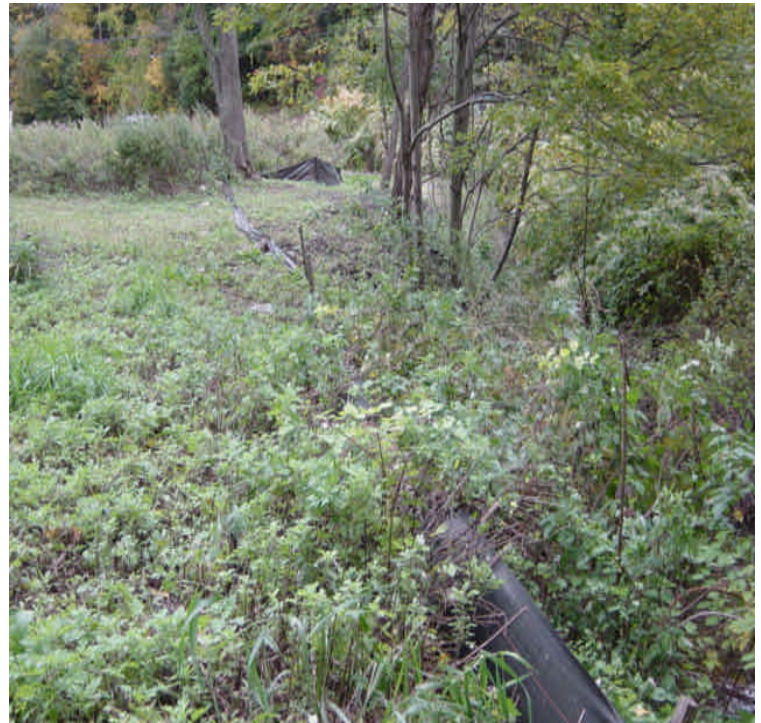
345kV (Route 7): Photo on the left shows a swale across from #848 Rt. 7 near the storage yard that has sediment accumulation. It is unsure whether this is from the project or something else. Photo on the right shows silt fence down at the same storage yard. 10/27/05

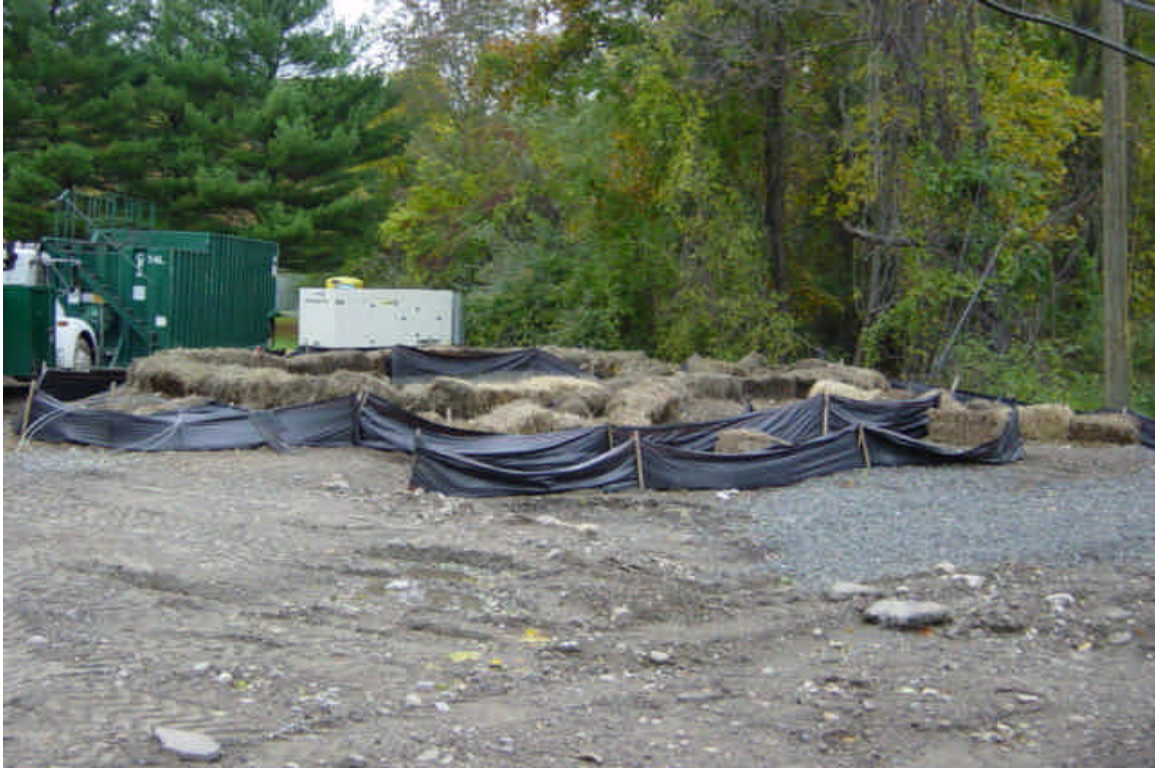
345kV (Wilton HS): Overall view of the settling basin where conditions have remained fairly constant since repairs were made last week. 10/27/05

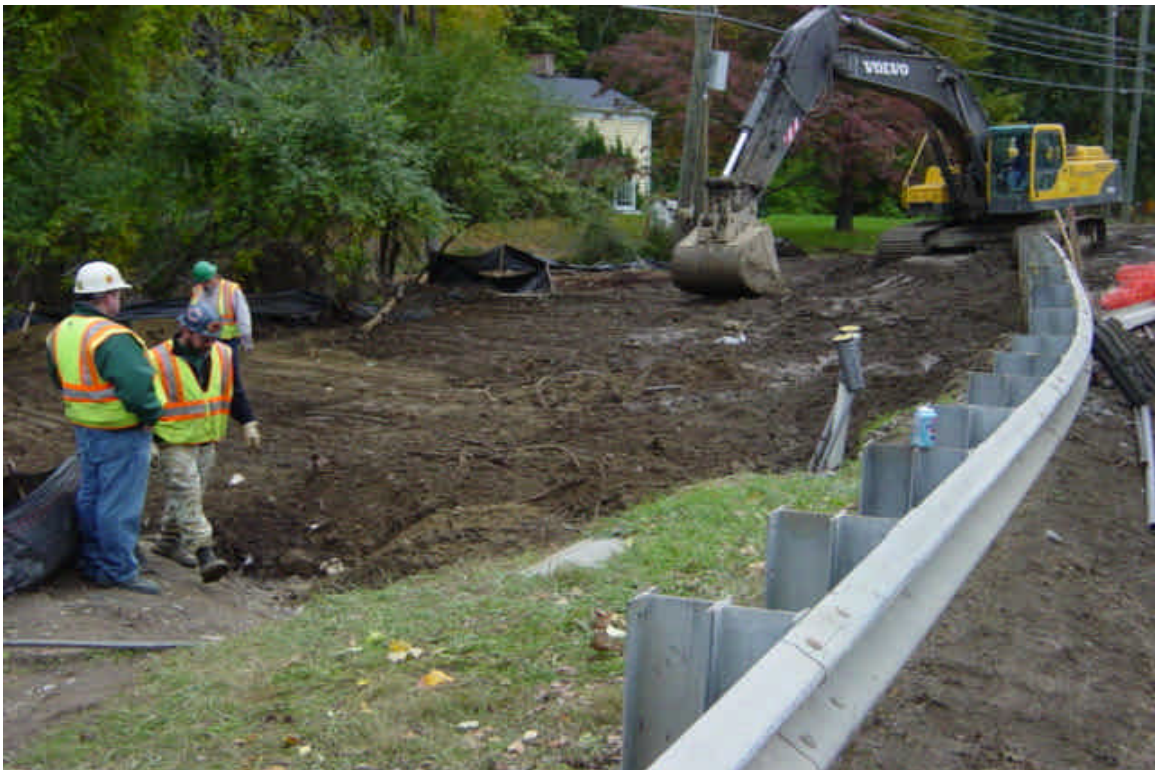
The northern receiving pit was being backfilled at the time. Erosion controls were knocked down during the work but will be repaired. 10/27/05

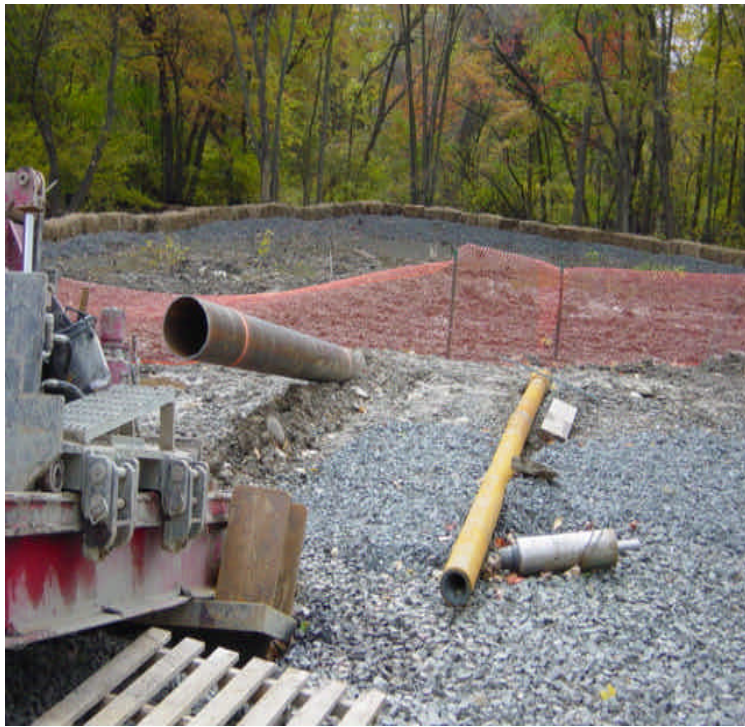
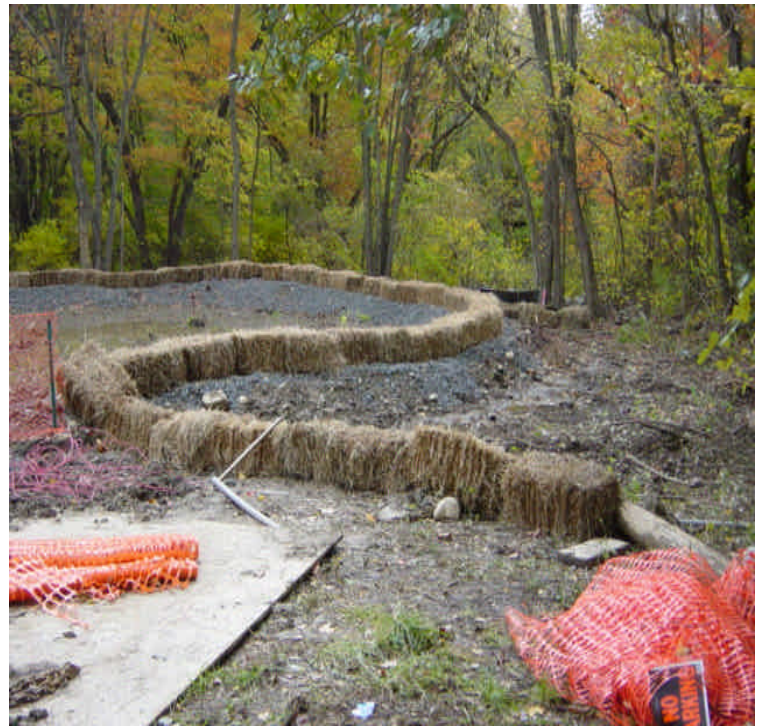
345kV Horizontal Directional Drill: View of the bore operation under the detention area that was built and placed with stone to hold any stormwater that runs through the area. Further views of the haybale and berm line. 10/27/05

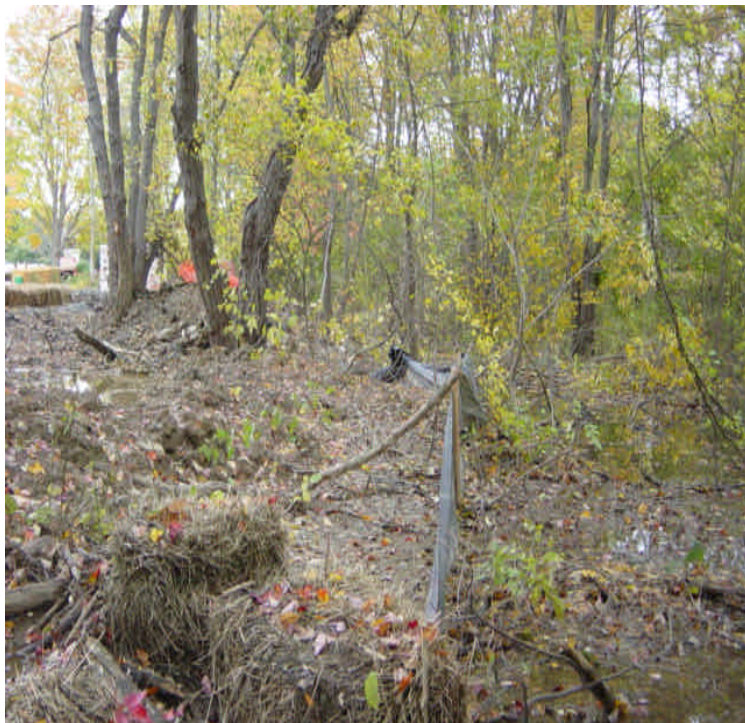
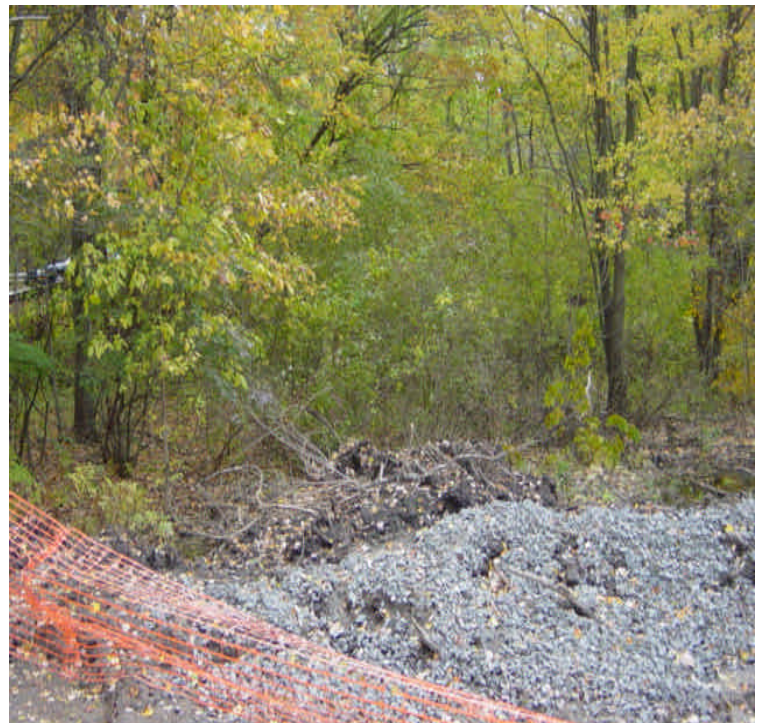
Photo on the left shows an area behind the berm and haybale line where repair to the additional erosion controls would add further barriers to sediment in the wetland. Photo on the right shows where stone and brush piles were placed beyond the erosion controls and should be pulled back on site. 10/27/05
